A CEMENT MILL FAILURE

THE CASE OF THE CEMENT MILL FAILURE

Subject : TRUGRIT Cement Mill Trunion Failure

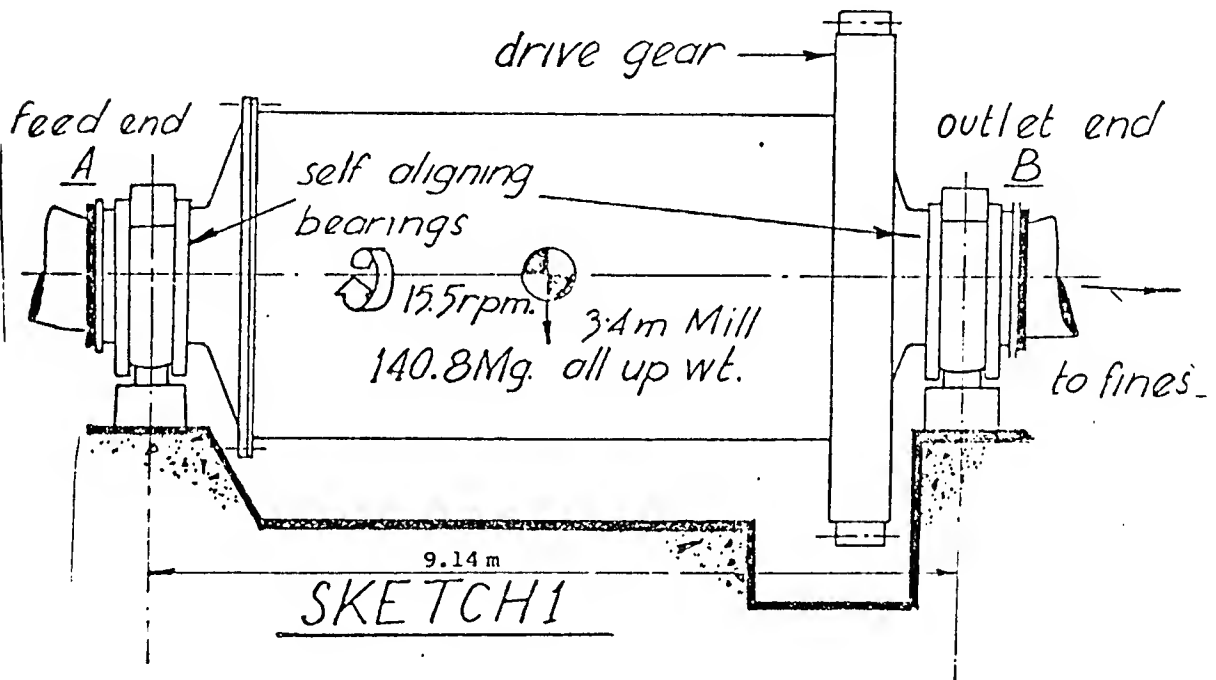
Amory(AA) : Correct me if I am wrong, but as far as I understand your operations look something like this: - (Refer Sketch 1)

1. Your mill is a conventional ball mill used for crushing raw feed, a material high in various clays such as broken bricks and quarried clay rocks.
2. The raw feed is fed in at the trunnion A, called the "feed end" and the feed is recirculated through the mill for another go.
3. Hot gases are also supplied at the feed end to dry the make-up feed for easier crushing.

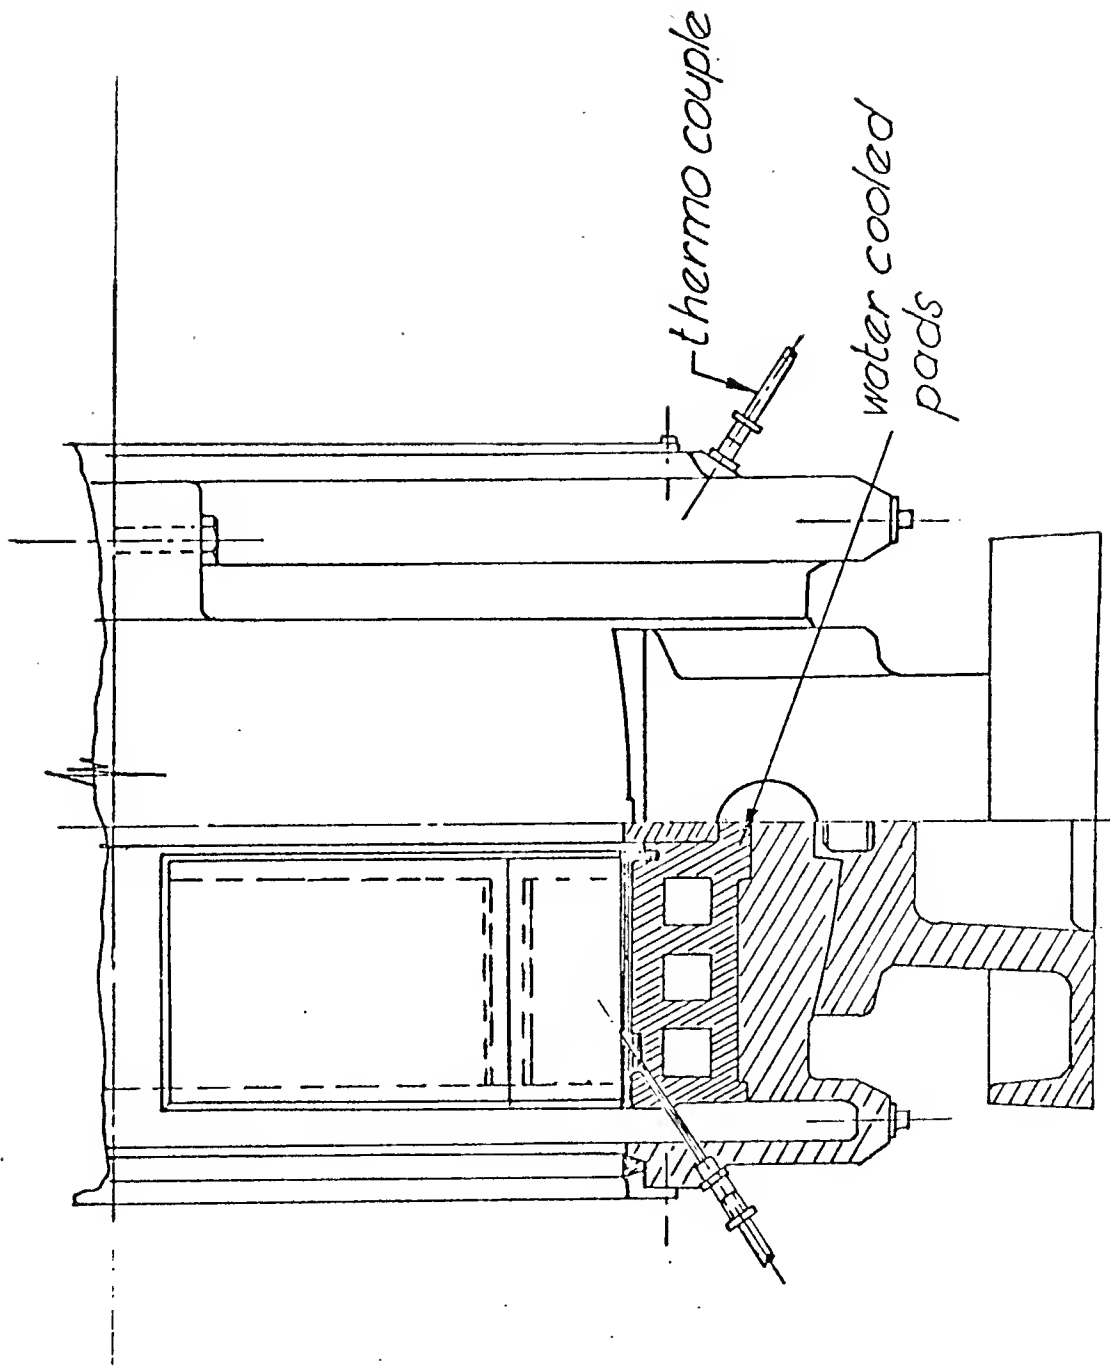
Exhibit B.
Section of
self-aligning
half bearing.

end funnelled out to a 3.8m diameter flange. The bearings were self-aligning half bearings with plain water-cooled pads. Amory observed the thermocouples embedded in the water-cooled pads.

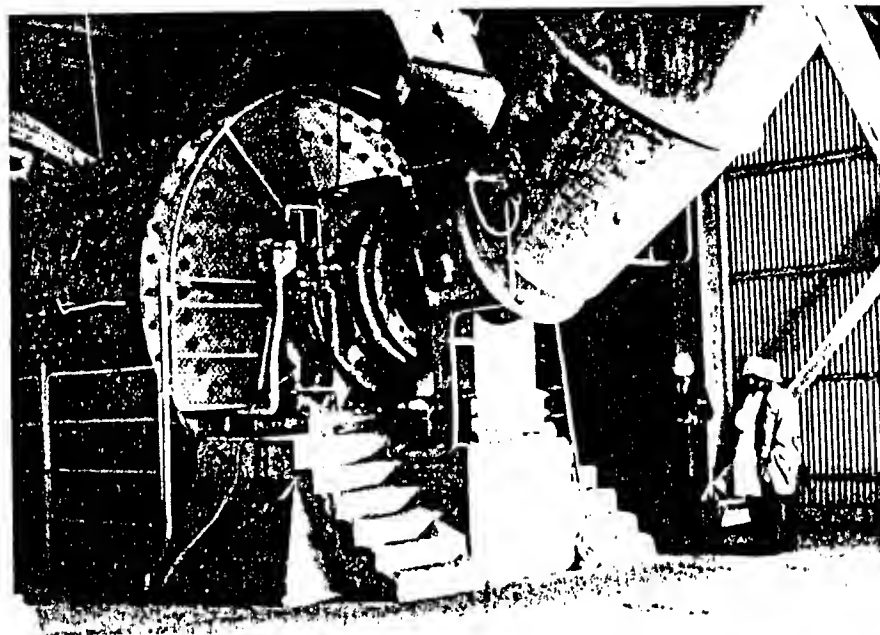
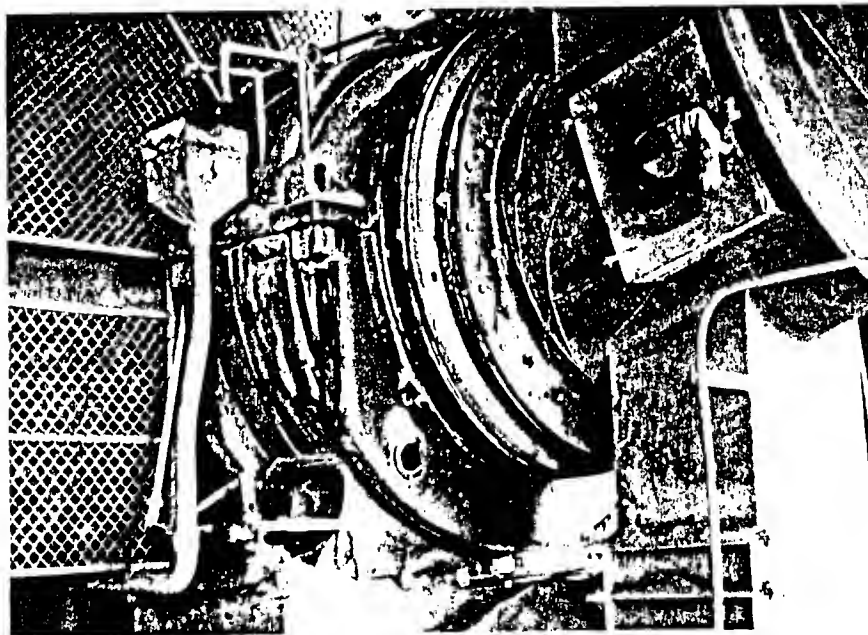
Exhibit C.

General view of mill and close-up of bearing.

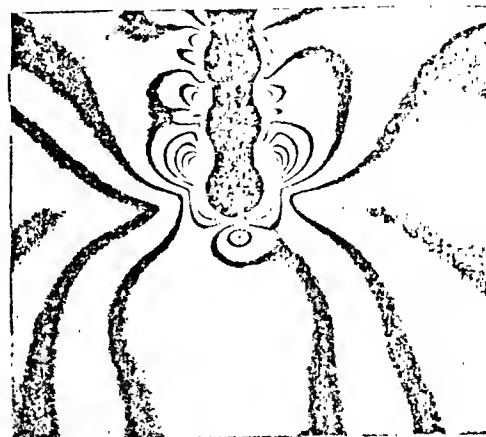
Figure 1.

Figure 1 shows stress distribution as developed in photo-elastic studies of METALOCK repairs. Although it is impossible to duplicate an actual repair in plastic, we may conclude that prestressing of the parent metal takes place as indicated. Such prestressing is of benefit in repairing castings subject to heat and pressure.

METALOCK is the trade name for specially formed keys made of special alloys. Slots are cut transverse to the fracture and METALOCK keys are inlaid by cold working into the parent metal. The alloys having a known tensile strength and the serrations of the keys having a known shear strength, a precise amount of strength is restored as each key is inserted.

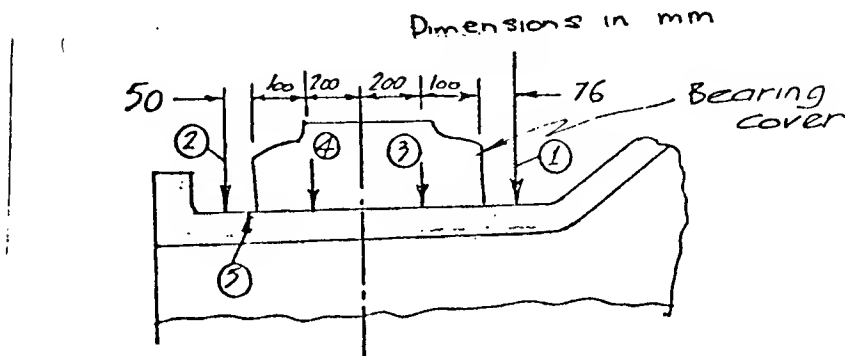
Schematic of Temperature Recording Stations

How would you analyse the trunnion given the temperature data in Exhibit F ?

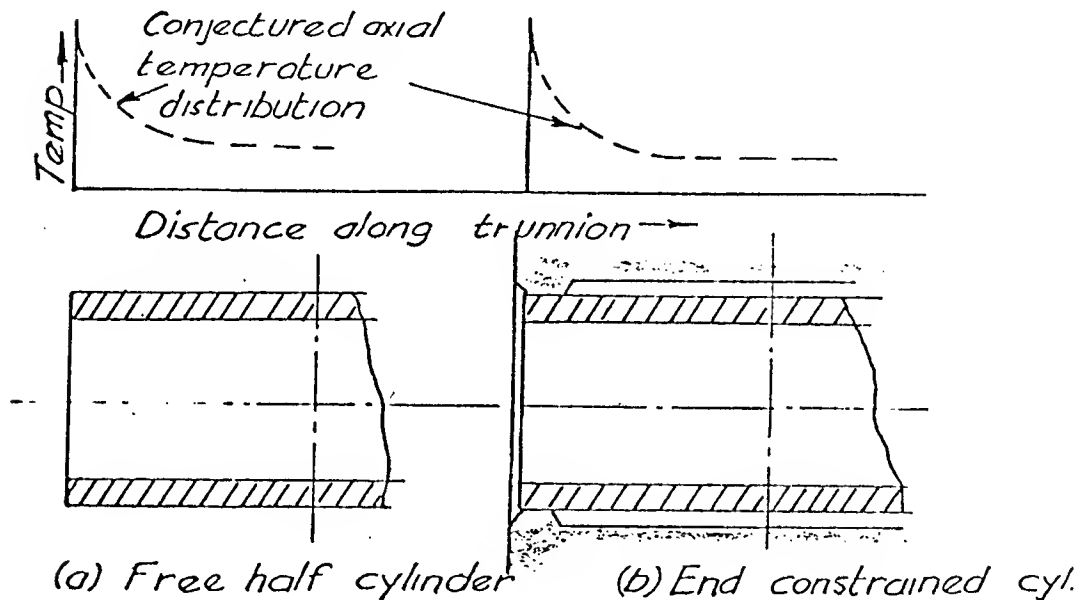
Sketch 4 - Trunnion Models Analysed.

In making his estimate of stresses due to thermal gradients Amory found a reference^{*} which treated the behaviour of thin cylinders under thermal effects. He considered two cases, namely :-

- (a) Free half cylinder with axial temperature distribution, and
- (b) a cylinder with constrained ends also with axial temperature distribution.

He reasoned that the flange at the outer end of the trunnion would impose a strong constraint to deformation and he hoped that (b) above, would account for this case. Details of the calculations for both structural as well as thermal effects are given in the Appendix. The results of these calculations showed that hoop stress levels in the trunnion could exceed the material yield strength when the gas temperature at the inlet exceeded 400°C. Amory felt relief when his calculations finally began to show significant stress levels. He felt he had isolated the real culprit in this case. He also felt

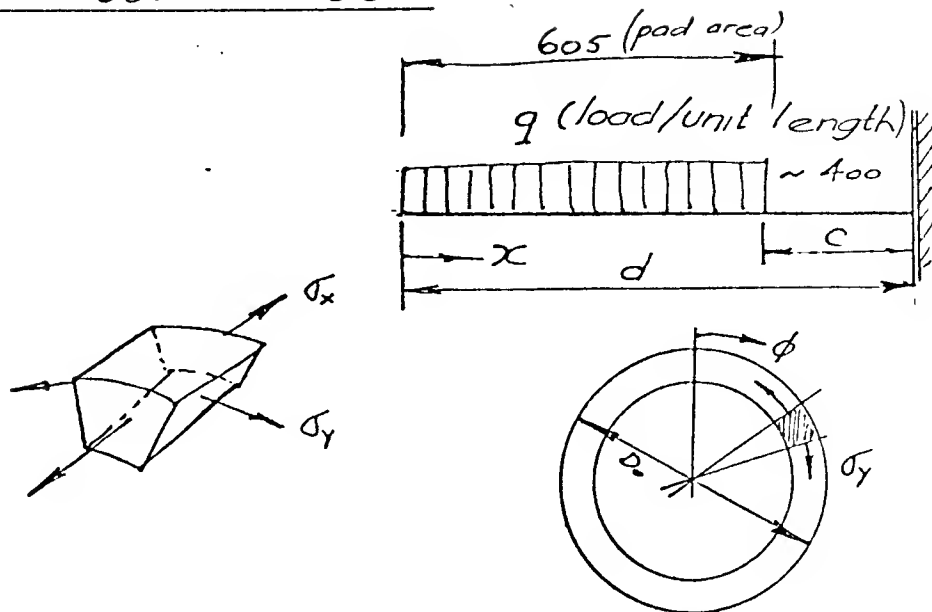
1. Stresses due to structural loads

Assume: selfaligning bearings do not "self-align"
trunnion is thin cylinder in bending.

$$\text{Load } q = (140.8 / 2) / 605 = 0.116 \text{ Mg/mm}$$

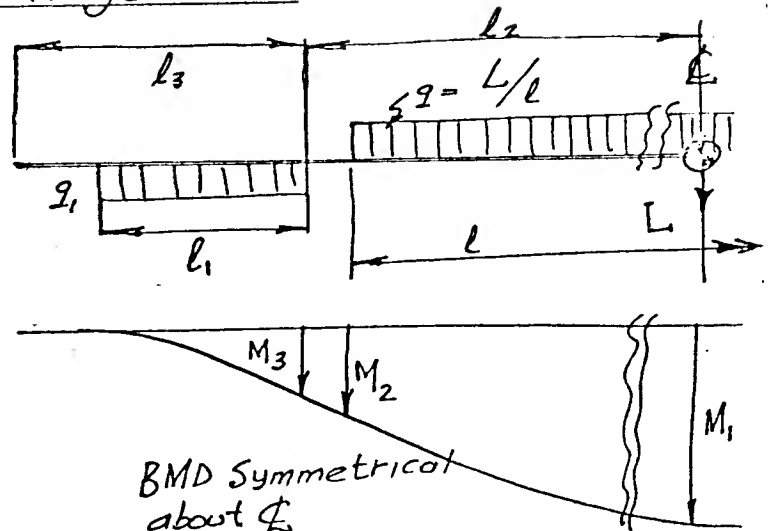
2 Deflection in journal

$$M_1 = \frac{1}{2}L \left\{ \frac{1}{2}l_1 + l_2 - \frac{1}{4}l \right\}$$

$$M_2 = \frac{1}{2}L \left\{ \frac{1}{2}l_1 + l_2 - \frac{1}{2}l \right\}$$

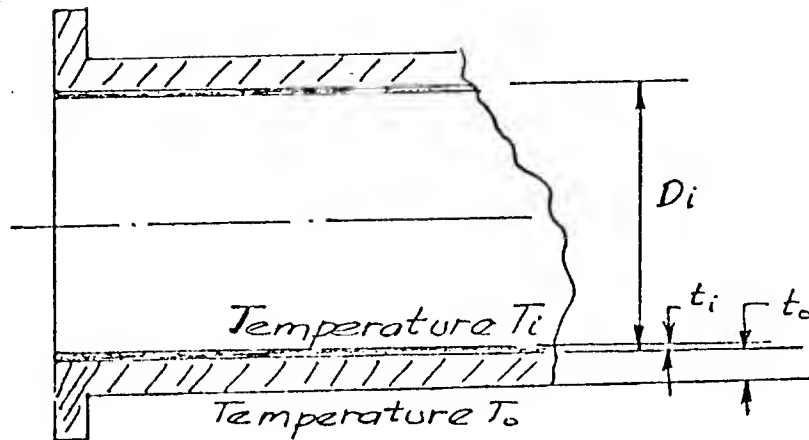
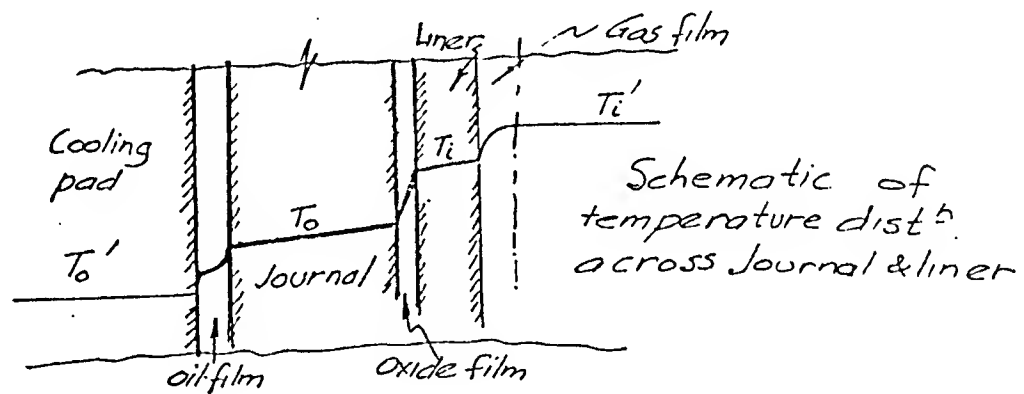
3. Differential expansion of Liner & Journal

3.1 original liner

Coefficient of thermal expansion $= \alpha / ^\circ\text{C}$

let pressure at interface be $X \text{ Pa}$.
